Instrumentation and monitoring: Early warning hopes

Predicting movement on a known landslide complex is not a simple task but Network Rails hopes that a new monitoring system in Kent will provide some early indications.

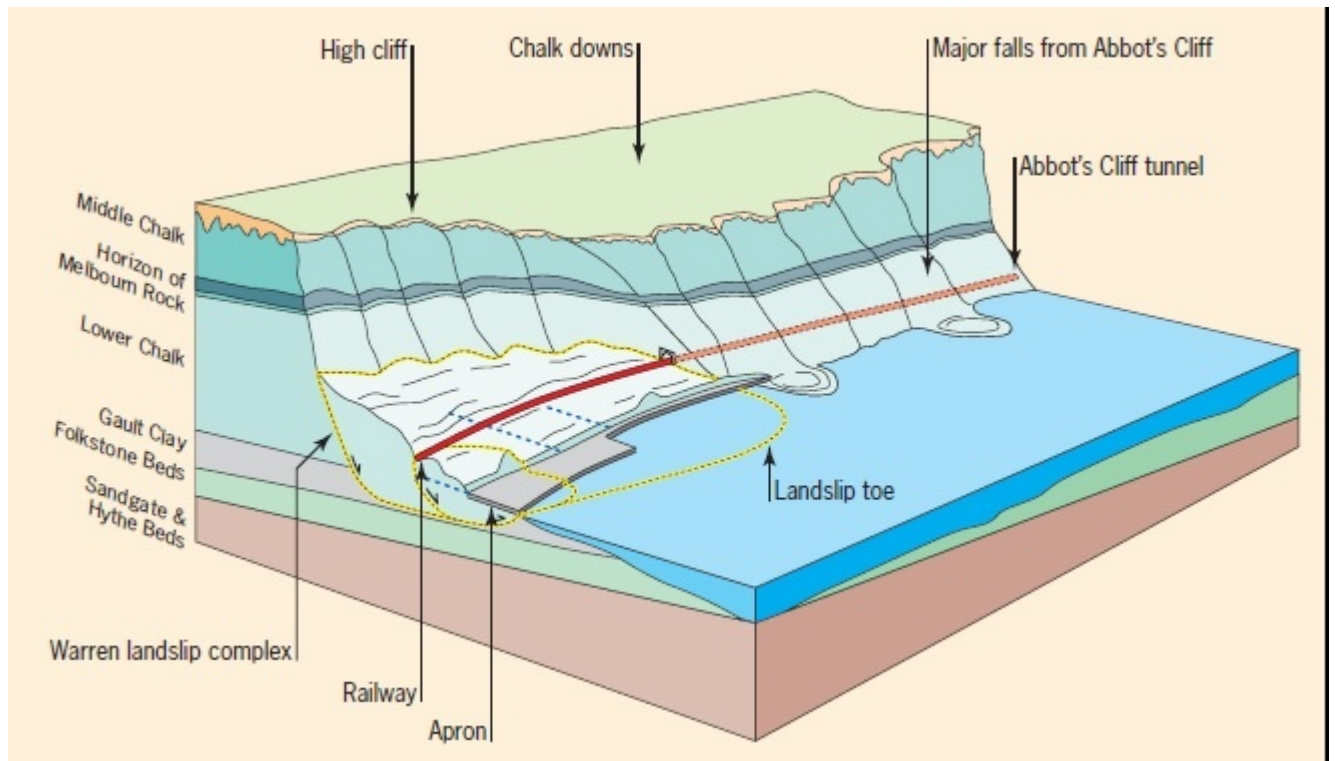
Ground movements have affected the rail line since it opened in 1844

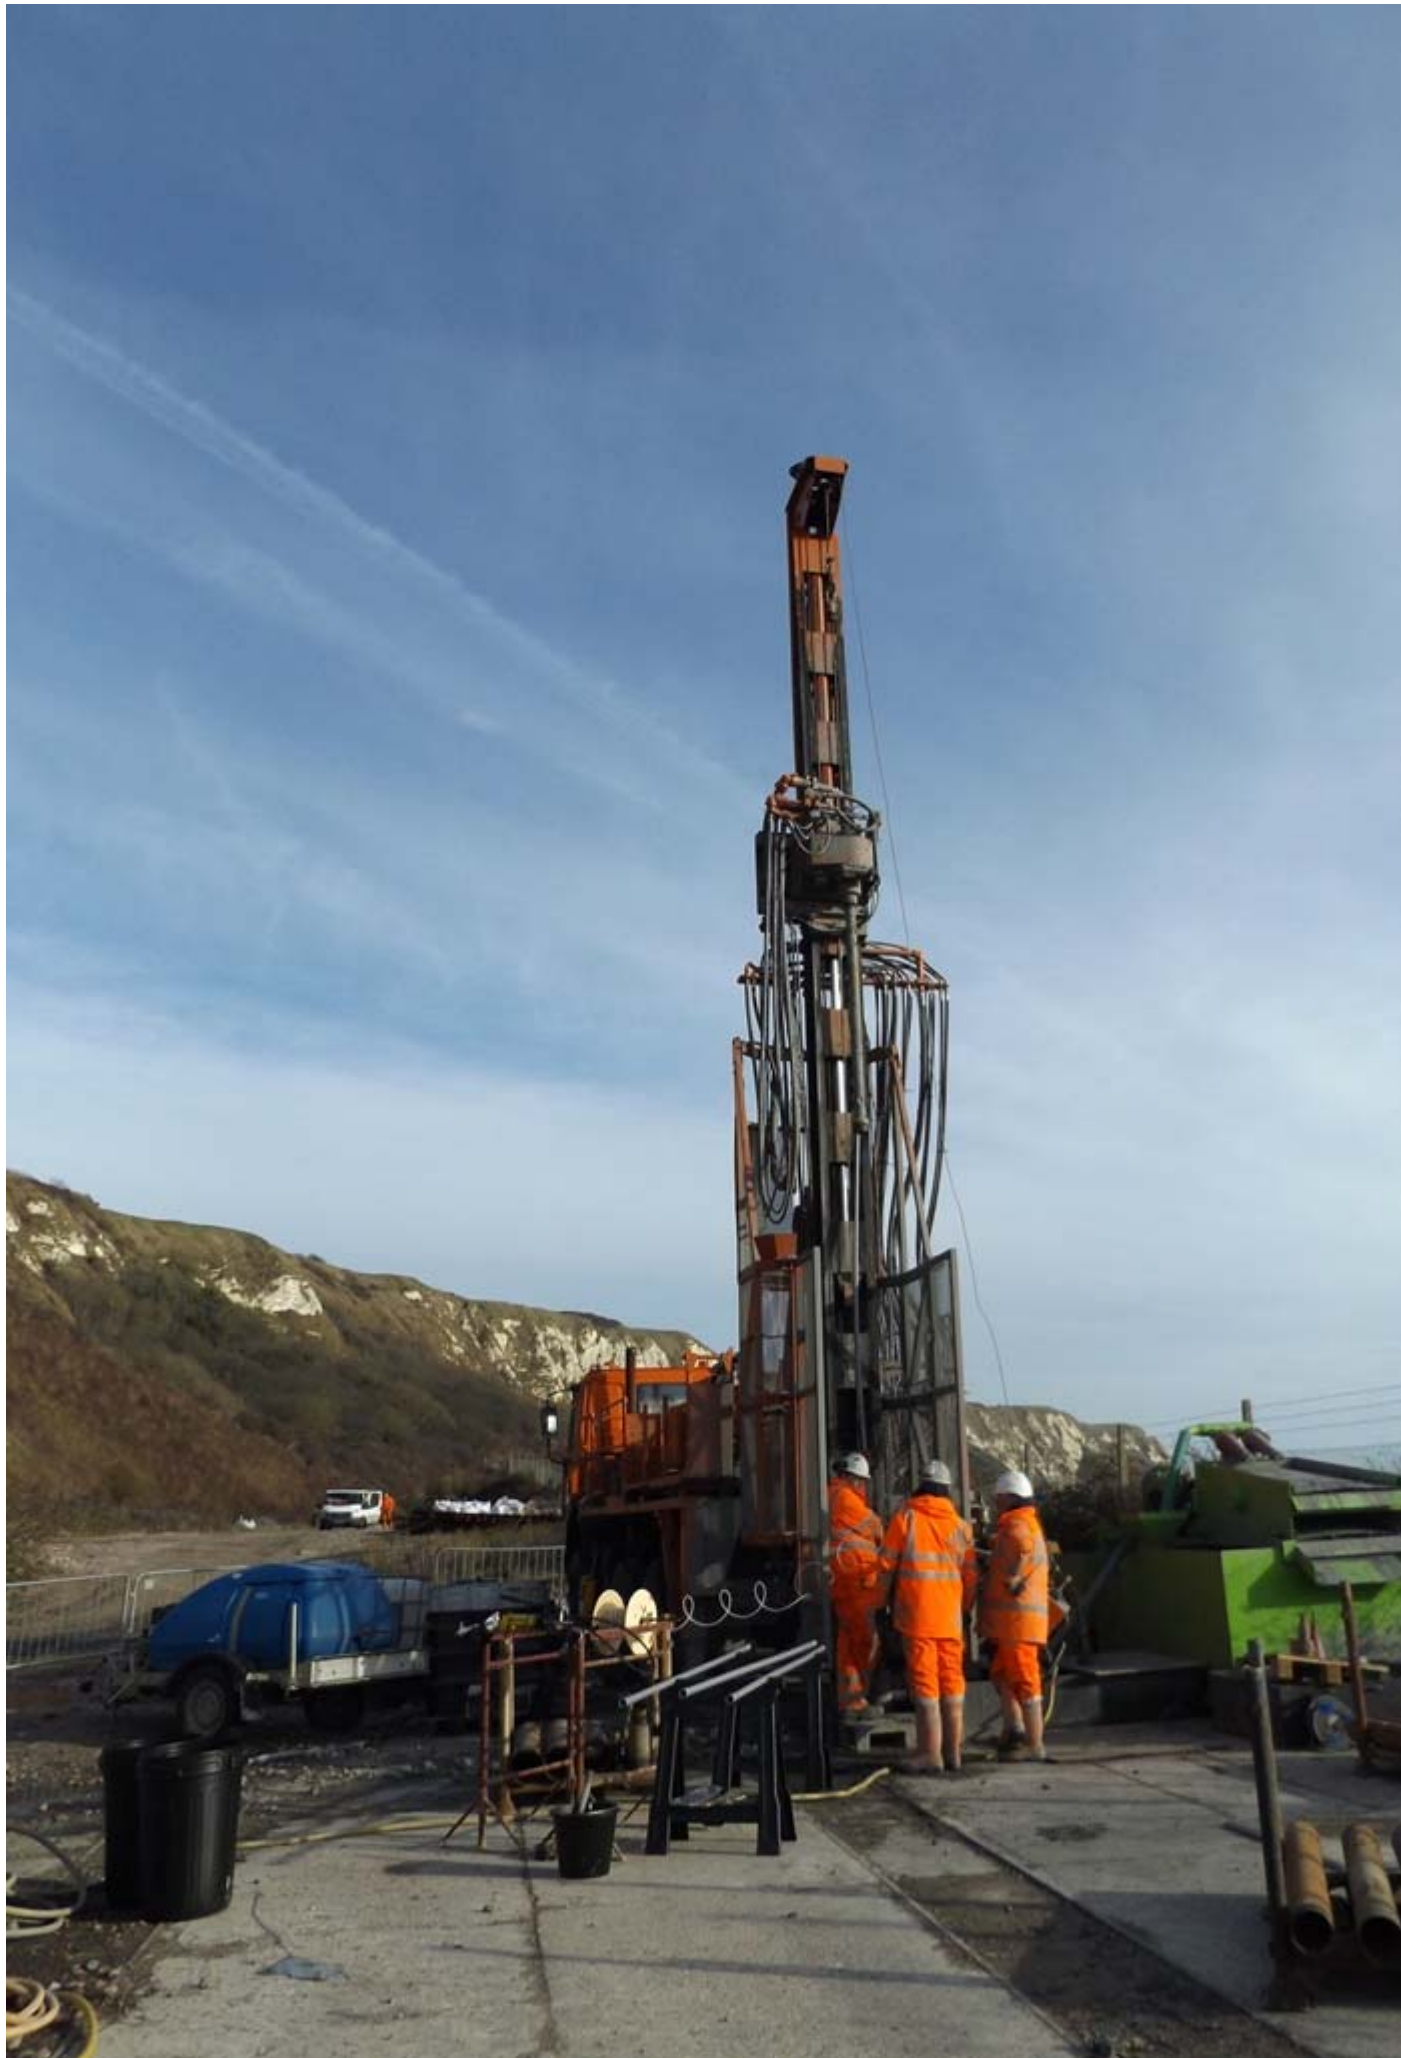
Boreholes are being constructed next to the rail line in the first phase and will be followed by a second phase on the back scar of the landslide

“The first stage involves constructing two 70m boreholes close to the rail line and Getec is installing a Shape Array Accelerometer (SAA), supplied by Geotechnical Observations, into the first hole,” says Butcher. “The second borehole will contain four vibrating wire cable extensometers and four piezometers located within the different geological horizons to measure heave and settlement. At the surface there will be a weather station to monitor the rainfall, temperature, wind speed and direction to aid a better understanding of how the weather impacts the extent of landslide movement.”

The second part of the work involves installation of two 8m long horizontal tilt arrays, also supplied by Geotechnical Observations, which will be installed in trenches outside of Network Rail’s land at the top of the landslide back scar and crossing a tension crack.

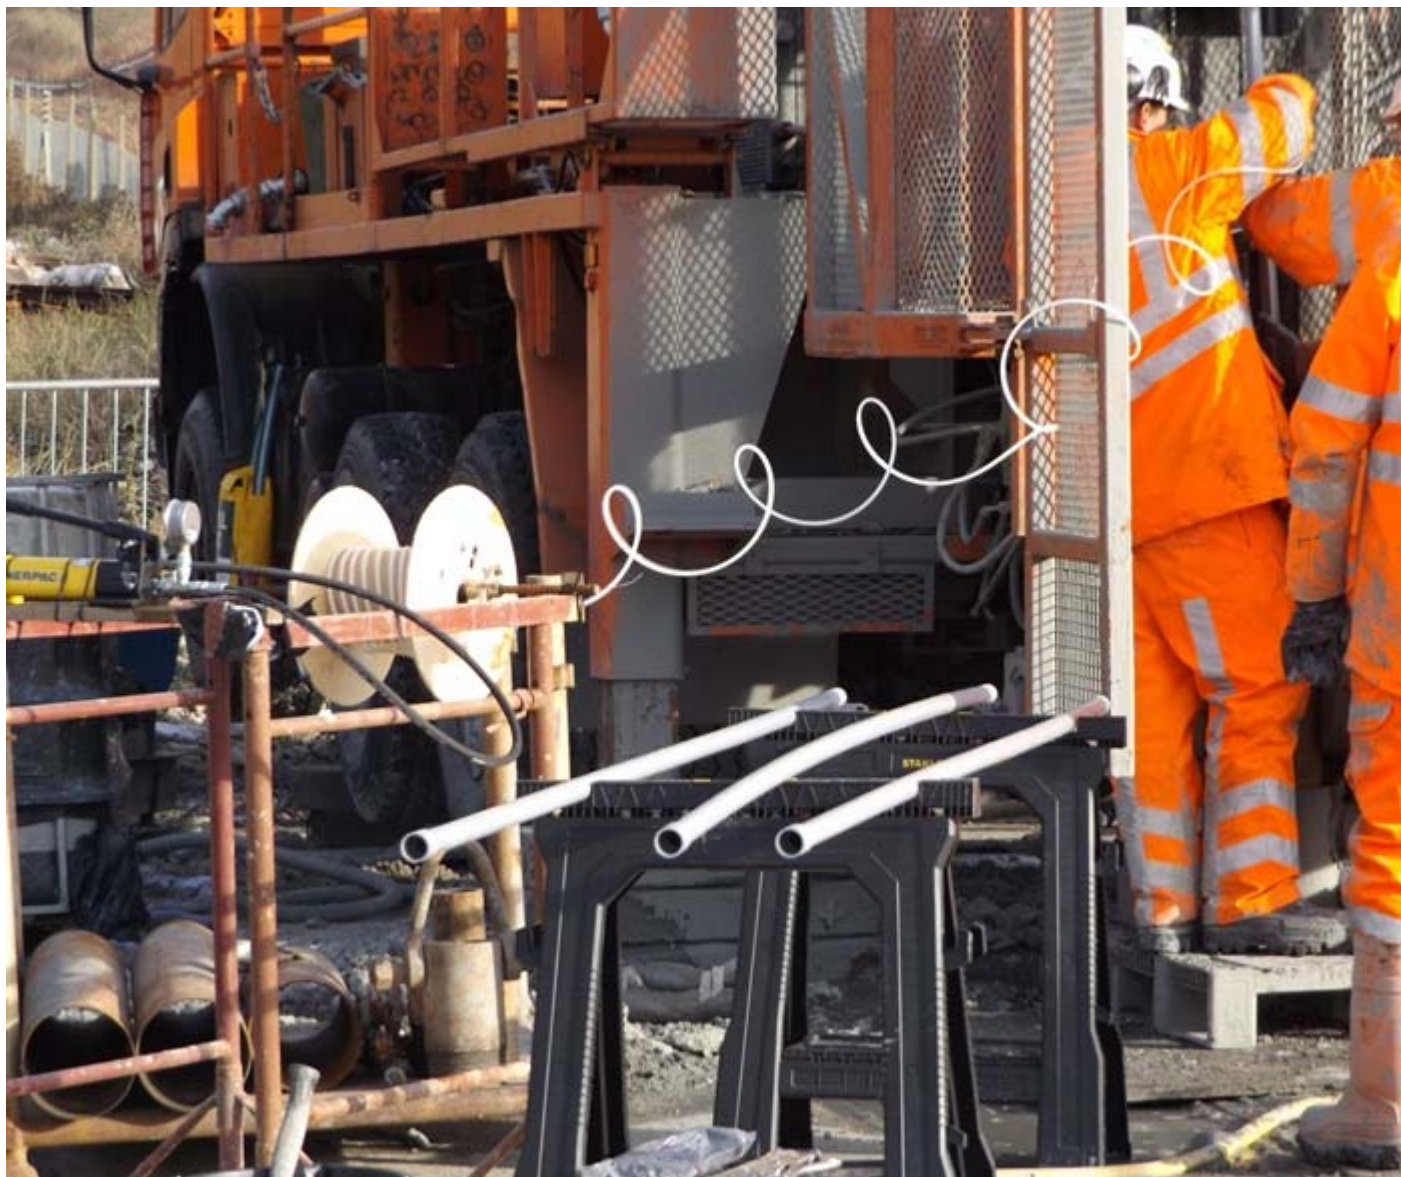
Two 70m boreholes are being installed to hold the monitoring equipment

“The borehole for the SAA was drilled to just over 71m and will be grouted over the bottom 15m to allow the SAA to be anchored at its base,” says Roffey. “The orientation of the array is key to getting the best data and Colin Warren has been providing us with guidance on this. The array is much better than inclinometers as it is more flexible.

“The piezometers in the second borehole will provide pore water pressure data within the Folkestone Beds, Gault and Chalk. These are formed by silicon cables with a nylon tube on the outside due to concerns over shearing or slack cables and better allow for the expected movement.

“The deepest of the extensometers will be placed at 65m to provide baseline data and all will be anchored into position. Movement will be measured by gauges in the headworks, which are normally used in the mining sector as conventional transducers would not be able to cope with the ground movement here.”

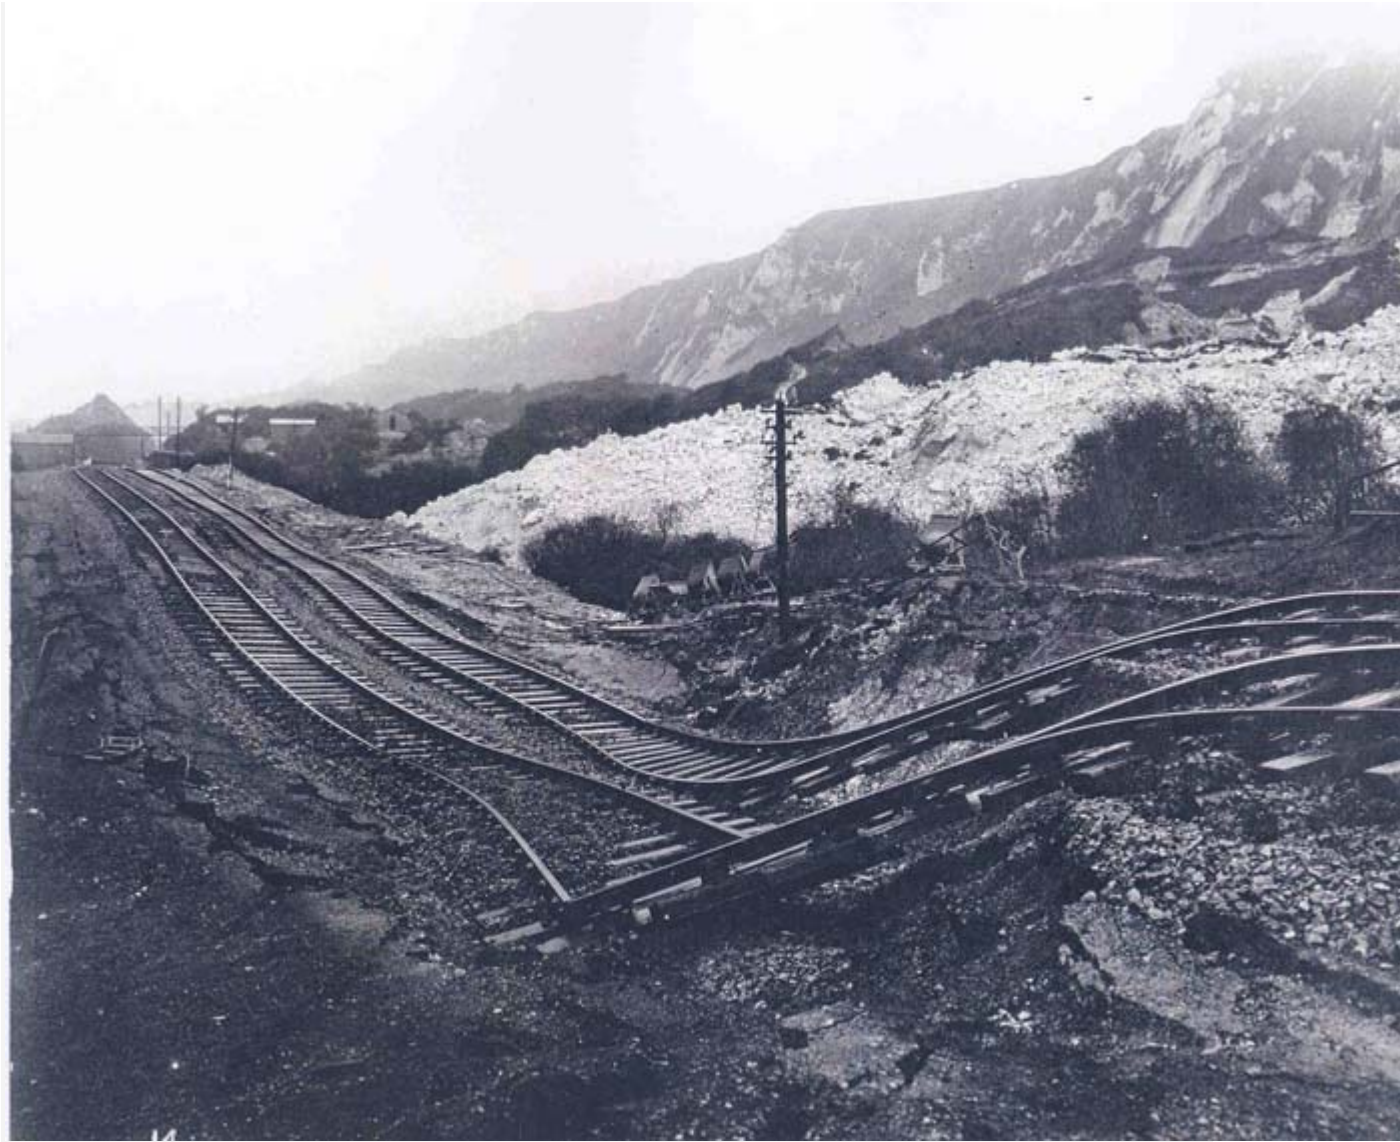
Ground movement in 1915 caused significant damage to the track close to where the current instrumentation is being installed.

In 1915 a major failure occurred resulting in rail lines being buried under up to 20m of debris and creating a debris flow 70m out to sea. A train was already on the section when the failure occurred but fortunately there were no serious injuries. However, the damage took four years to repair.
